## SITE PRACTICE & TROUBLESHOOTING COATINGS ON BRICKWORK ANTI-GRAFFITI, WATER-PROOFERS AND WATER-REPELLENTS

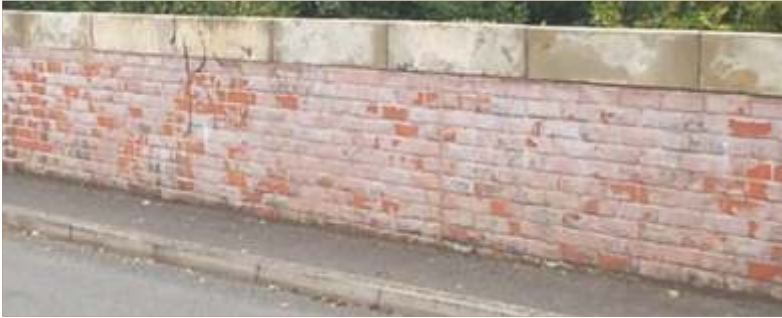
Unsuccessful anti-graffiti coating

Some types of treatment however, are not satisfactory there has been an unacceptable deterioration of the coat, i.e. it has gone brittle, opaque and flaked off, creating a most unsatisfactory appearance.
