DESIGN & SPECIFICATION CONSIDERATIONS EXPANSIVE PARTICLES

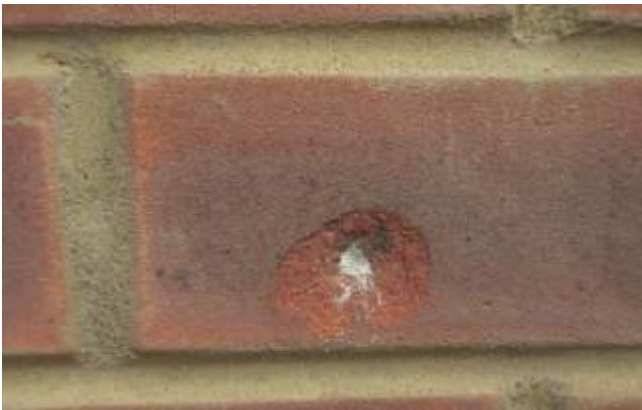
Expanded lime particle.

After firing, when the brick absorbs moisture, a chemical reaction takes place. The particles swell which, if close enough to the surface may cause portions of the brick face to “pop” off.

The results are small pits in the surface of the brick with a white (lime) or purple (siderite) spot in the centre.

The expanded particle is drilled out to provide a more substantial key for a filling material. The depression is then filled with a suitable material, such as a compound of a cementitious/resin nature, which is coloured to closely match the original brick colour and additions of various sands etc. are used to provide a similar texture.
